**SOLAR PHOTOVOLTAIC INDUSTRY**

**CIGS MANUFACTURING PROCESS AUTOMATION RELIABILITY**

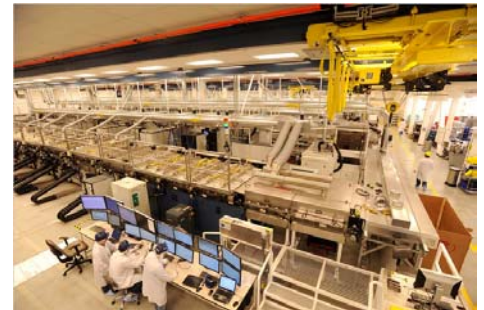
*Photovoltaic Processing Line Utilized Many Carrier Transfer Systems Multiplying the Impact Of Tool Reliability Issues*

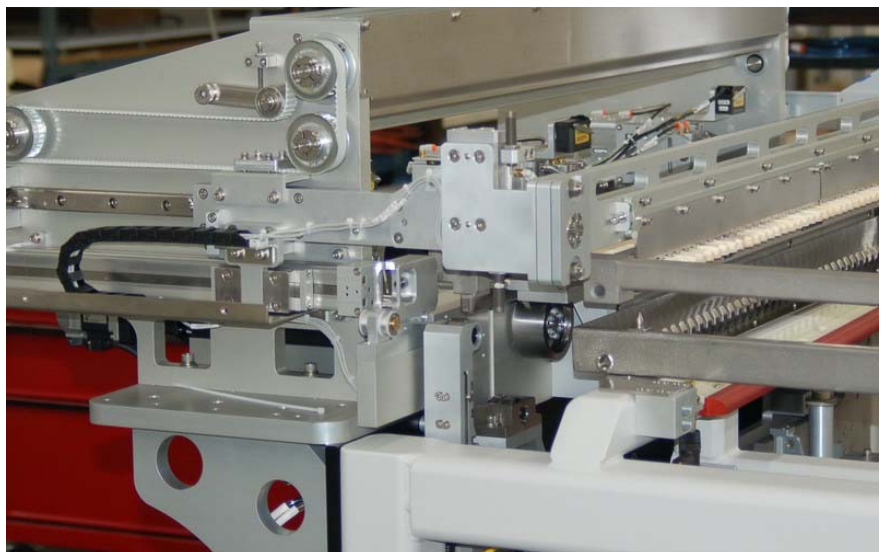
*Closeup of Mechanism for Transferring CIGS Glass Substrates*

Owens Design worked collaboratively with the client to identify the thermal, mechanical, and alignment issues. Over several design cycles scheduled to coincide with the client's manufacturing line upgrades, all of the critical mechanisms were redesigned. The carrier design was modified to improve alignment references. Extensive training was conducted to improve system calibration and maintenance operations. The overall result was that the system reliability increased by 50 times.
